Manhole Inspection Summary

Manhole # S17QQ1005MH

Location Address: **12 CORALBERRY CT**

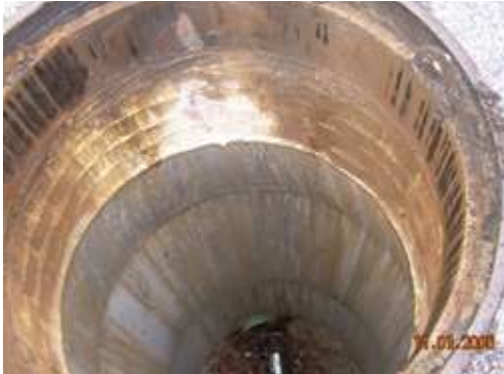
Defect

☒ **Leaks**

Infiltration: ☐ None ☒ **Joint** ☐ Cracks ☐ Mortar ☐ Roots ☒ **Wall**

Frame leaks. Adjustment infiltration.

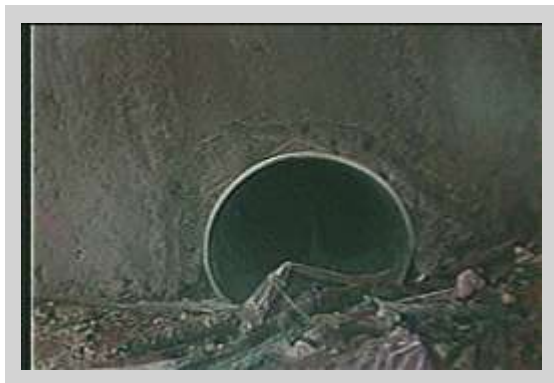
Pipe Out @ 12 O'Clock

Deposits: ☐ None ☐ Mud ☐ Sludge ☒ **Debris** ☐ Grease

Deposits Extent: **Light**
